# Alexandra Basin Redevelopment Project

## Environmental Impact Statement

**Volume 2** | Appendices

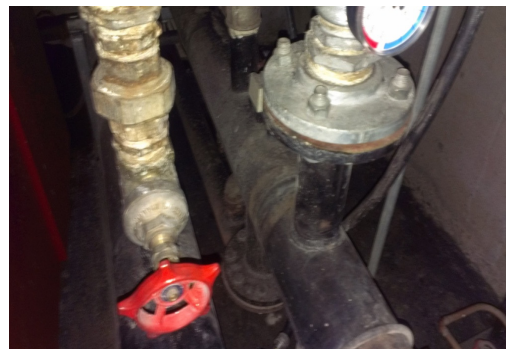
**Site:** Alexandra Basin, P&O Head Offices **Floor:** Ground  
**Room Reference:** Boiler Room **Form:** Gasket - Card  
**Location & Description:** Gasket  
**Extent:** <1m<sup>2</sup>  
**Sample Number:** (15) - BEL1022  
**Lab Reference Number:** BS071836  
**Lab Result:** Chrysotile  
**Recommended Action:** See Comments

**Comments:** The asbestos should be removed during the normal maintenance programme of the building. The works do not require a licensed contractor, however the material should be disposed of as asbestos waste.

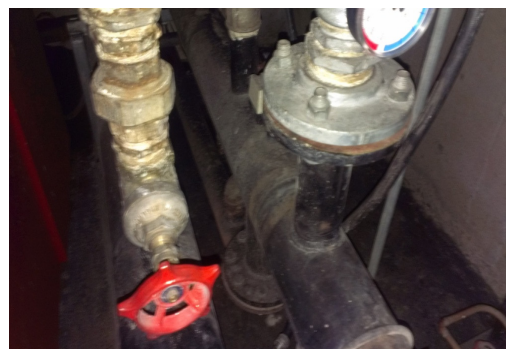
**Site:** Alexandra Basin, P&O Head Offices **Floor:** Ground  
**Room Reference:** Boiler Room **Form:** Gasket - Card  
**Location & Description:** Gasket  
**Extent:** <1m<sup>2</sup>  
**Sample Number:** (16) - BEL1023  
**Lab Reference Number:** BS071837  
**Lab Result:** Chrysotile  
**Recommended Action:** See Comments

**Comments:** The asbestos should be removed during the normal maintenance programme of the building. The works do not require a licensed contractor, however the material should be disposed of as asbestos waste.

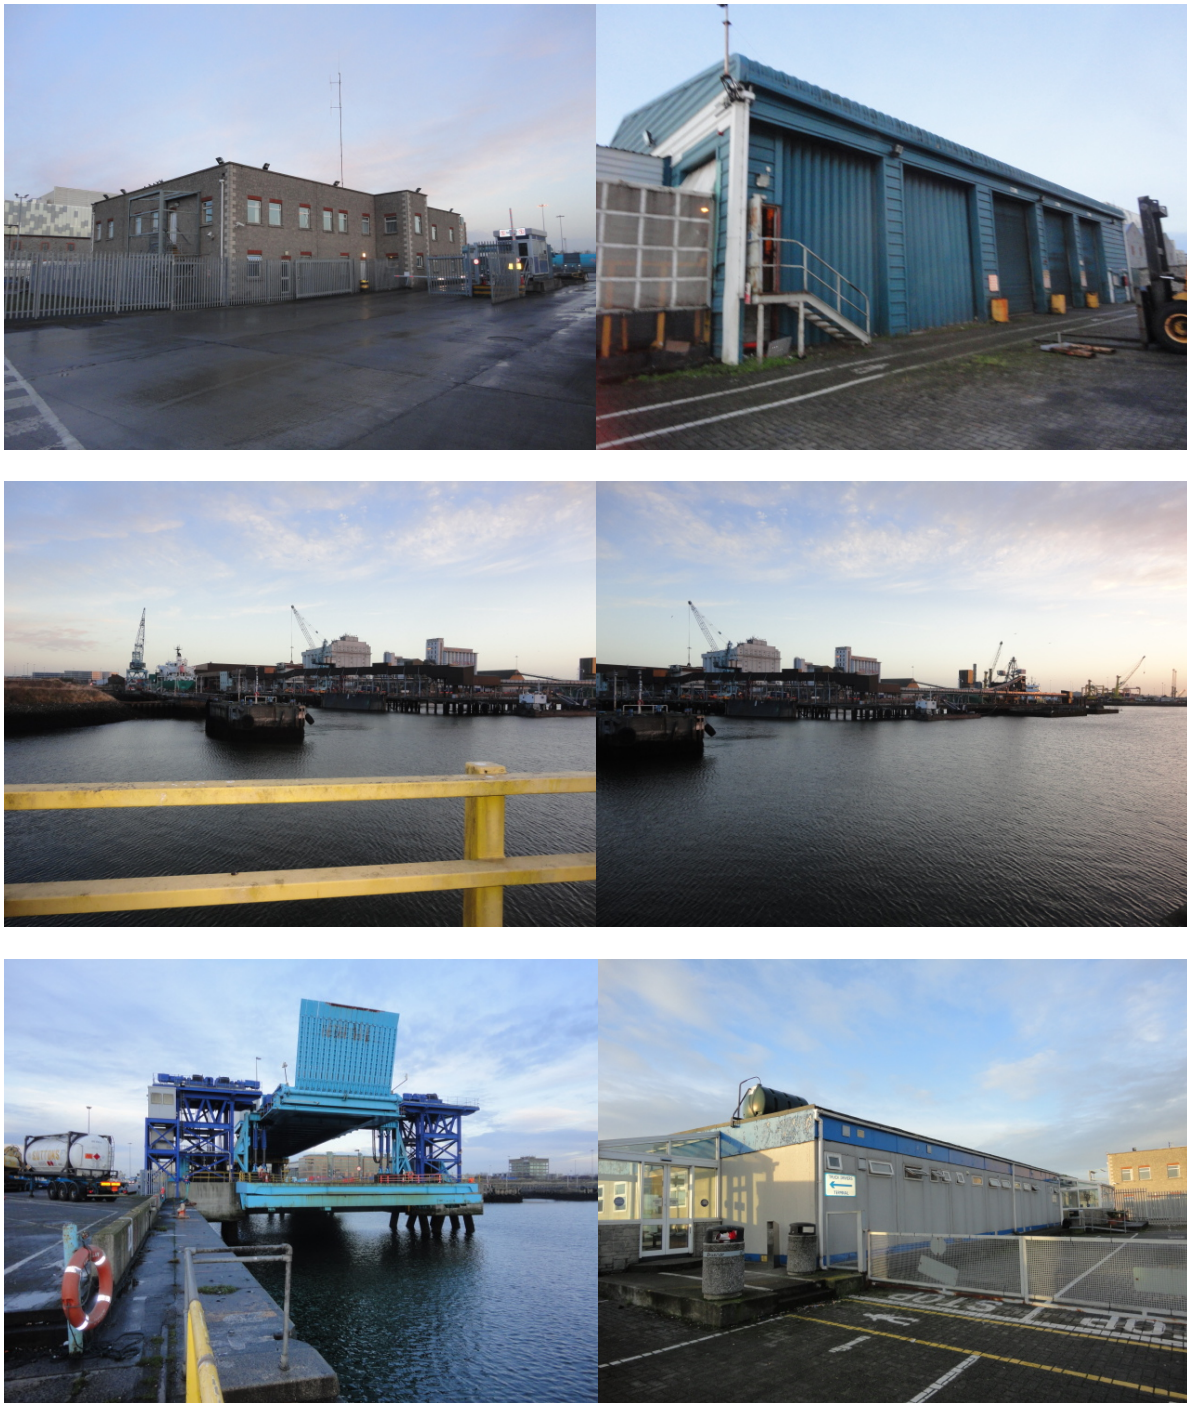
**Plates 1-6:** Series of photographs of structures and buildings within the survey area.

The array of buildings and structures inspected consisted of the following:

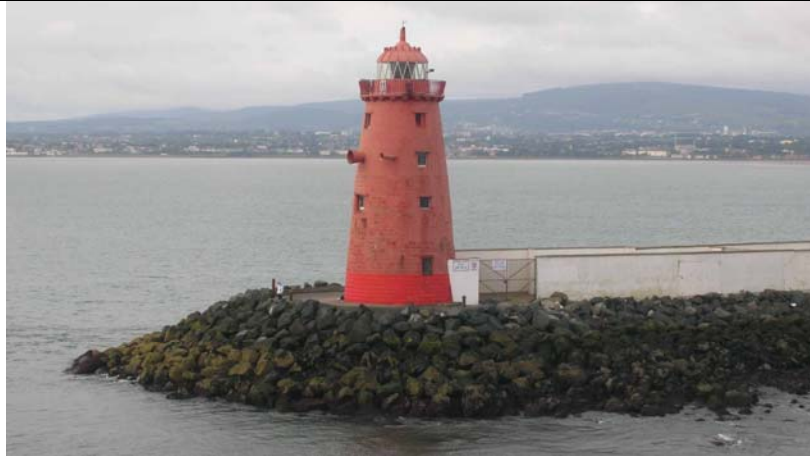
Detail from OS First Edition 6-inch map showing extent of Poolbeg Lighthouse c. 1837, showing an incomplete roundel at the terminus. <a href="http://www.osi.ie">www.osi.ie</a>	Poolbeg Lighthouse, view looking South from within the Approach Channel, showing extent of modern rock armour protection at base of lighthouse, at Low Water.

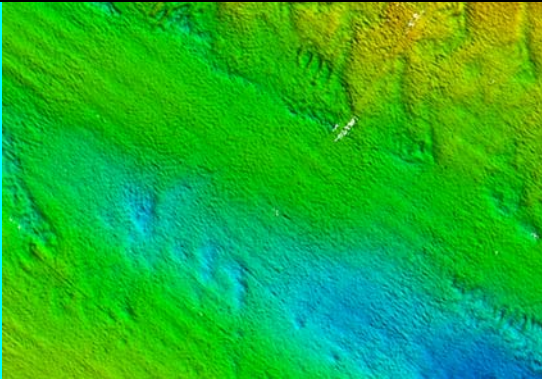
GSI INSS Multi-beam image of seabed at coordinates for W01551, revealing no distinctive indication of wreckage. The pale blue shading on the multi-beam image indicates a tongue of deeper water extending southeast.						
W01552	Unknown	Unknown	INSS G161a possible wreck, measuring 3m long, 3m wide, 3m high off the seabed, in a general depth of 8m.	unknown	053 20 01.572	006 05 21.984	727248.743	733204.908	
W01553	Unknown	Unknown	INSS G161b possible wreck, measuring 3m long, 3m wide, 3m high off the seabed, in a general depth of 8m.	unknown	053 20 02.436	006 05 22.524	727238.043	733231.219	
W01554	Unknown	Unknown	INSS G161c possible wreck, measuring 3m long, 3m wide, 3m high off the seabed, in a general depth of 8m.	unknown	053 20 03.552	006 05 22.02	727246.366	733266.079

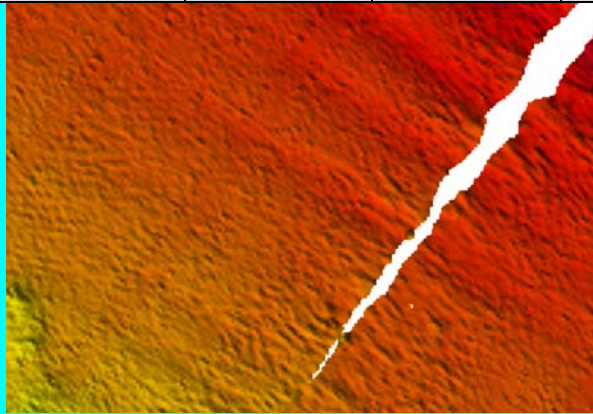
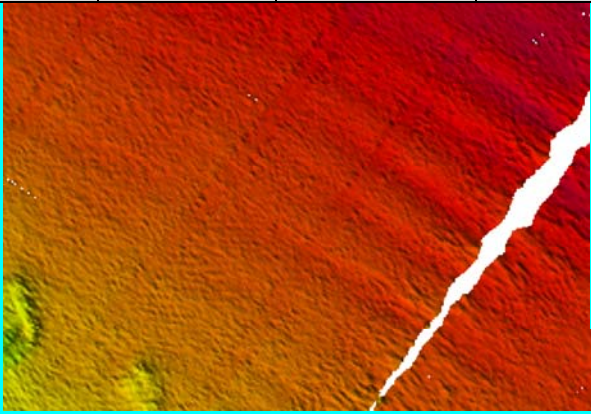
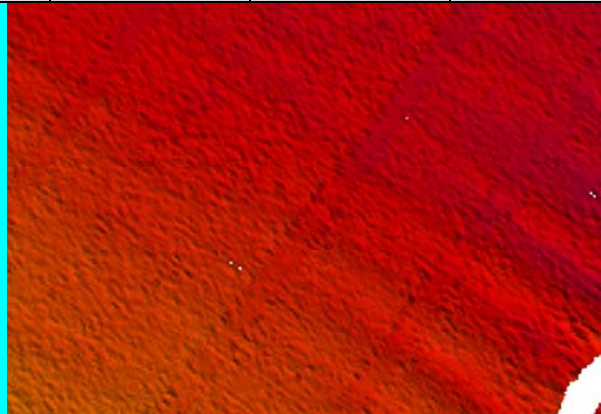
GSI INSS Multi-beam image of seabed at coordinates for W01552, revealing no distinctive indication of wreckage.			GSI INSS Multi-beam image of seabed at coordinates for W01553, revealing no distinctive indication of wreckage.			GSI INSS Multi-beam image of seabed at coordinates for W01554, revealing no distinctive indication of wreckage.			
W01734	Unknown	Timber vessel	Timber vessel with timber and iron fastenings, and an iron knee with bronze fastenings, observed during dredging operations for the Dublin Bay pipeline in 2001, at Shellybanks, South Bull. Oriented E-W. Musket balls and bullets associated.	mid-1800s	053 20 10.50	006 10 42.39	721314.453	733325.985	None
Redeposited			Archaeological timbers from W01734 redeposited at known location		053 20 13.33	006 10 47.28	721221.769	733411.138	None

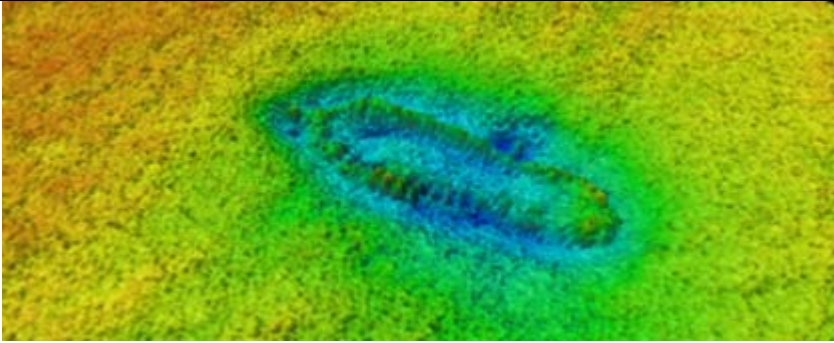
This wrecksite was found as part of a survey for the Ringsend WWTW effluent Outfall Extension. It lies 350m Southeast of Poolbeg lighthouse. It is clearly defined on a multi-beam data trace, defining a linear shape with both ends intact and perhaps the bow section facing Southeast. A series of short linear elements distinguishable on the side of the vessel may indicate timbering. It measures 16.4m long, 5.5m wide and is 0.2m in height above the surrounding seabed. Possible associated debris is indicated off-picture to the WSW of the stern section.

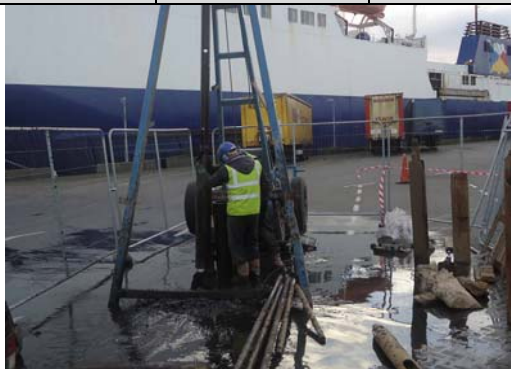
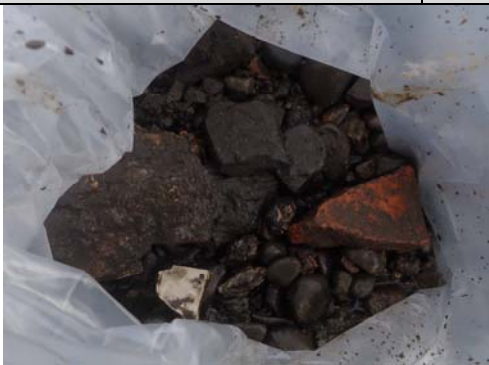
View of coring operation, C1, 4/11/2013			View inside sample bag from C1, showing nature of MADE GROUND material, which includes ceramic waste pipe sherds	
BH C1A	Ditto above	11.50m	Below a surface level of concrete was 2.3m of MADE GROUND, consisting of sand, gravel, cobbles, boulders, and concrete, with a strong hydrocarbon odour. This overlay 50cm of MADE GROUND with black clayey fill with metal, timber, glass, which overlay 4.9m of SILT with grey black sand and some gravel, over dense grey fine-to-coarse GRAVEL with cobbles and boulders, which continued to base of core.	None
RC C1A	Ditto above	24m	Rotary Core was employed to continue depth of core to 25m. Symmetrix Drilling observed c. 1.5-2m thick layer of layers of silty clay with some gravel bands alternating with silty clay, extending to 18.5m, over grey clay to 22m over a c. 1m thick band of dark clay, over gravelly clay and occasional boulder, which continued to bottom of core.	The presence of dark clay at 22m may indicate an outwash clay layer.

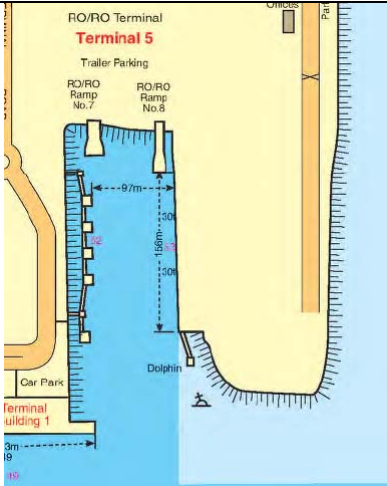
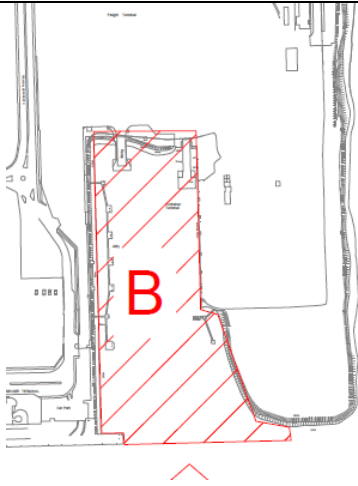
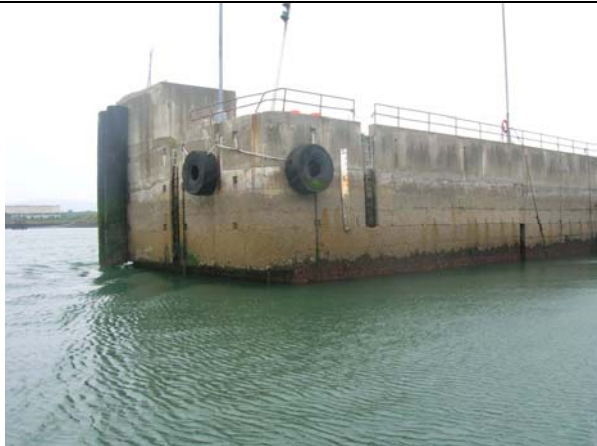
<p>Detail from Port of Dublin Company Estate map, showing location of Berths 52/53 and current usage</p>	<p>Detail from Project Drawing highlighting area proposed for infill works, highlighted in red hatching</p>	<p>View looking S at the inside of quay at riverside terminus of Berth 52</p>

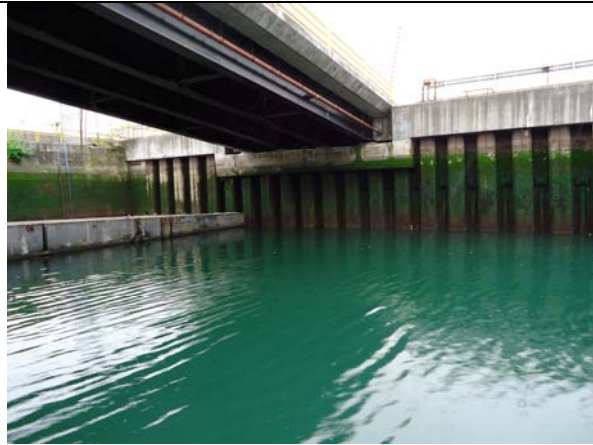
Concreted façade of Terminal 3 and Ramp No. 4. The ramp will be relocated to the N as part of ABR works

The works required on North Quay Extension as part of the ABR project will relocate Ramp No. 4, which is currently located next to the quay at its westernmost basin side; and demolish Ramp No. 6, which is located on the riverside of the quay. It will also demolish portion of the quay, by removing the basin-side of the quay and the easternmost c. 150m of the quay, the latter constituting most of Mallagh's completion works of 1931. It should be noted that the original western extent of the quay on the basin side will not be affected, as it lies concealed beneath Terminal 3. Associated dredging works will deepen the seabed along the riverside and within the basin so that the new bed level will lie below the base of the quay. The current bed level is -7.3m OD on the basin side and -8.5m on the channel side. The existing foundations on the basin side within the works area will be removed. The surviving section of the foundation on the channel side extends to c. -7.05m OD. The proposed new dredge depth within the basin and along the channel will be -12m OD, with the potential future dredge depth within the channel to -15m OD.

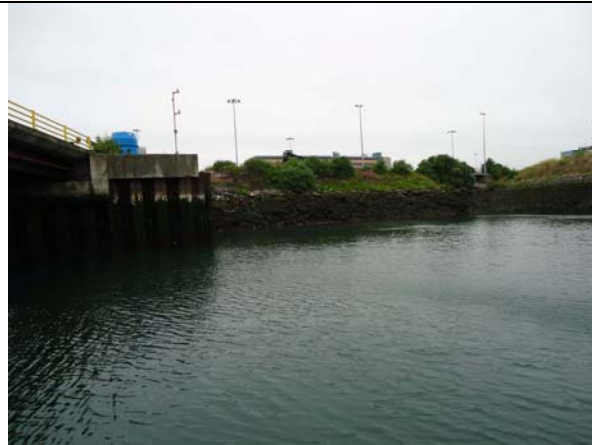
Looking W at infill from c. 2008, to be removed as part of ABR works

Removal of the recent infill beside the Lead-in jetty will serve to reinstate an element of the former footprint of Alexandra Basin. One of the historic shipwreck sites associated with the Port and the Approach Channel is located under this area of recent infill. Given that this location is close to the old shipbuilding and repair yards, it is possible that remains of a vessel were abandoned here.

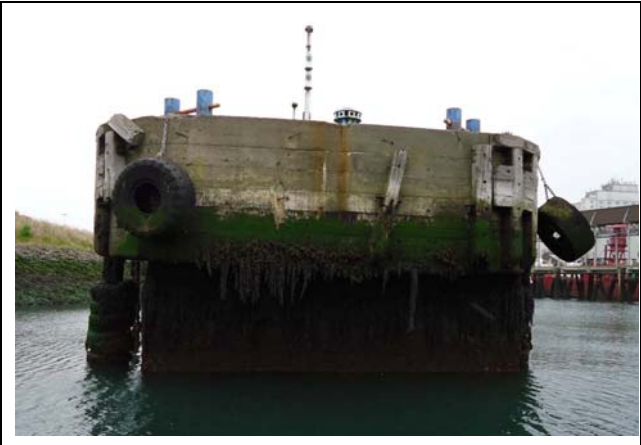
Concrete terminus of Lead-in jetty, the jetty will be demolished as part of ABR works

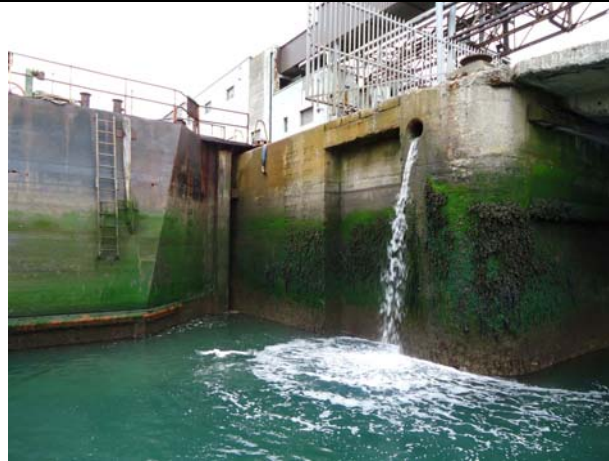
View looking NW at entrance to Graving Dock No. 2, built in late 1950s. The Dock will be filled in as part of the ABR works

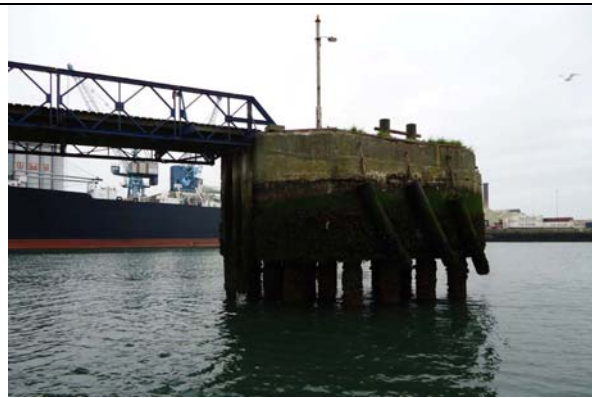
View looking N at dolphin ramp associated with ore/bulk jetty. This feature is imaged on the side-scan sonar traces (ss79\_1)

87_2	53°20.8256N	6°13.3356W	718366.42	734458.84	Foundations for ramp off Alex Basin NQWE north side. Forms two rows of up to four lines of supports.	12.16	N	n/a	Ro Ro ramp features

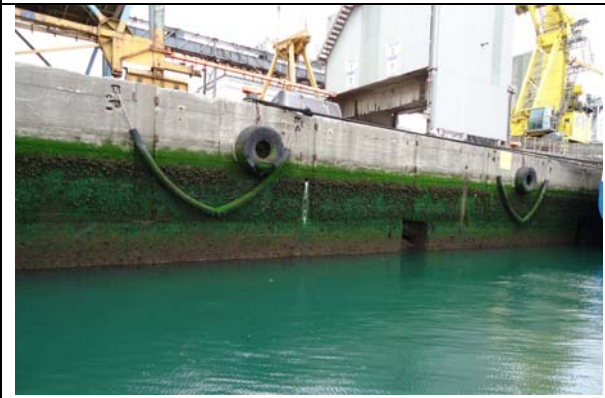
View looking N along Alexandra Quay, showing the mass concrete façade that defines its construction from the 1920s

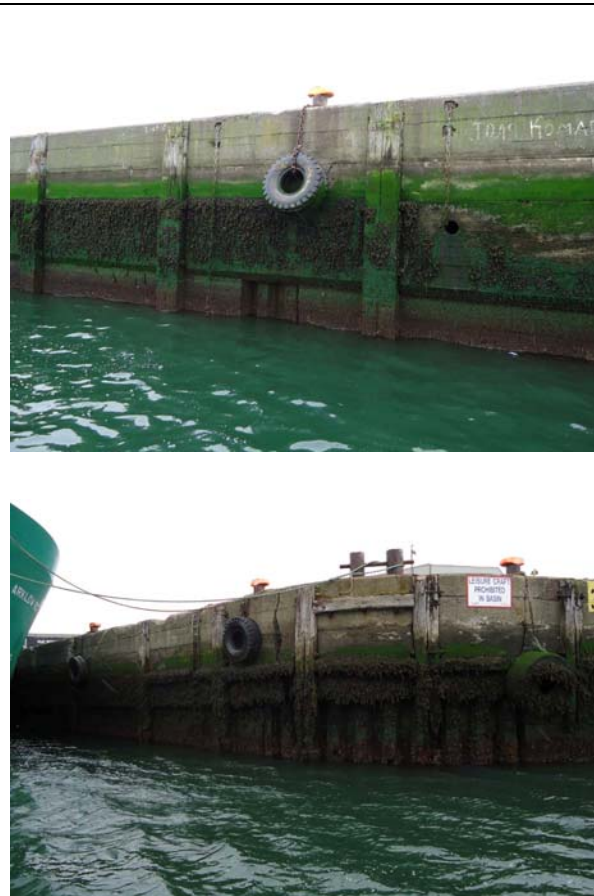
Views looking E (top) and NE (bottom) of Ocean Pier, showing its mass concrete construction of 20th-century date.

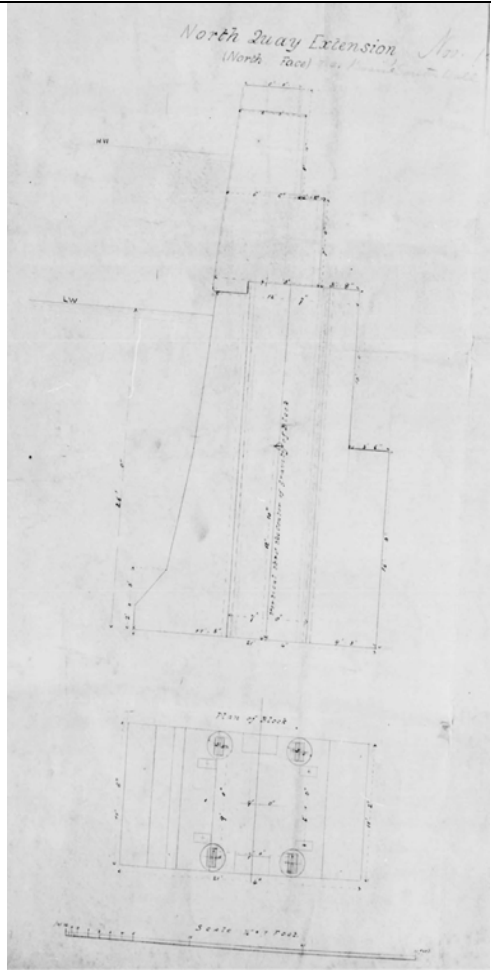
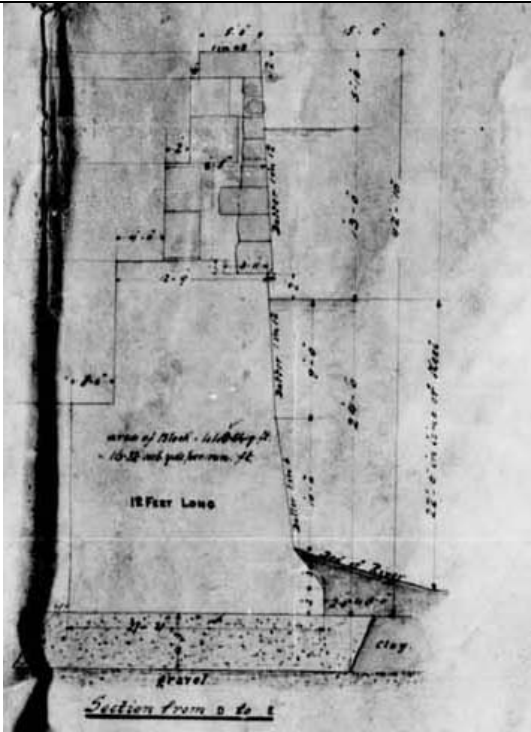
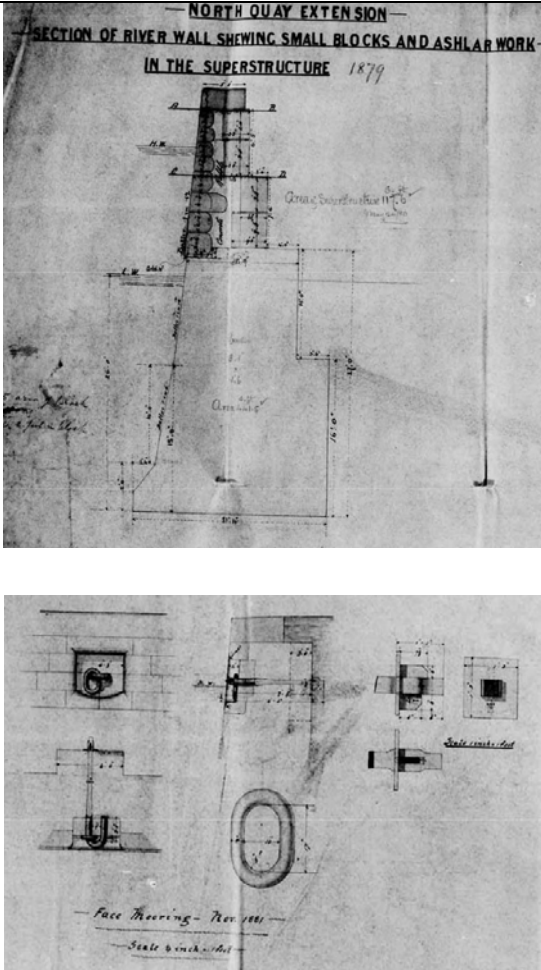
<p>Port Archives Ms 7933 shows a caisson in cross section and plan view from the north face (basin side) of the quay, dated 1875.</p>	<p>Port Archives Ms K1047 'North Quay Extension, progress sections of wall', detail showing section type at D-E, channel side, with key to location inserted below</p>	<p>Port Archives Ms 7929 'North Quay Extension, section of river wall shewing small blocks and ashlar work in the superstructure 1879'.</p>

Large cast iron girders were incorporated into the bottom of the blocks and wrought iron lifting bars attached. Large granite stones weighing up to two tonnes each were used in the construction to bulk out the cast concrete. The stones were edge-set side-by-side. Large rebates were cast into the blocks to take stone facing blocks for the new piers and in some instances, part of the stone facing work was completed on the blocks while they were still on dry land. Each foundation block measured 21'4" wide at its base, but there was variation in height, between 26' and 29' high. Each block had a stepped profile in cross-section that was recessed by 3'6" at the rear, and this could also be of varied height, between 9'6" and 13'. The variations reflect the bespoke nature of each block.

The blocks would be then floated over the prepared seabed, and dropped into place to form the foundation façades. Grooves cast into the blocks were subsequently filled with concrete to key them together. The space between the two lines of foundation blocks was filled with spoil from ongoing dredging operations aimed at deepening the basin. The Port Archives records indicate a bed of gravel underneath some of the caissons, suggesting that the divers may have purpose-laid gravel beds where necessary in advance of the caisson being dropped. The blocks extended in height so that their topmost level would be exposed at Low Water, allowing completion of the quay structures 'in the dry', in the manner that the quays right along the Liffey were constructed. The Port Archives show the level of detail given to the granite facades, including the stone-cut recesses to accommodate mooring rings and the requirements to ensure that the mooring rings were adequately founded within the structure and fabric of the quay wall.

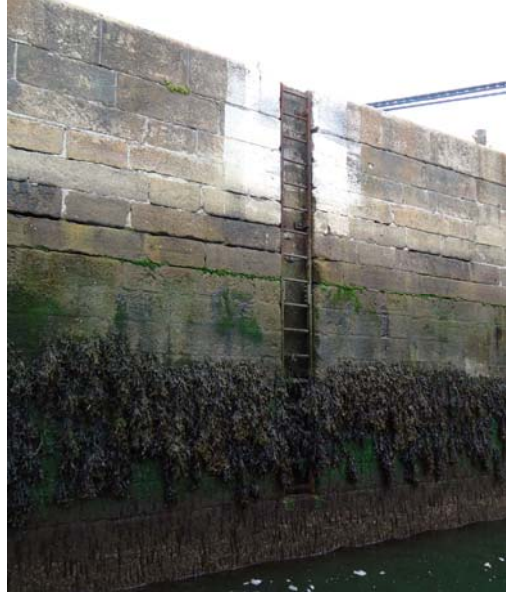
A photograph of a stone wall made of large, rectangular blocks. A metal access ladder is attached to the wall. The base of the wall is covered with dark, dense vegetation.

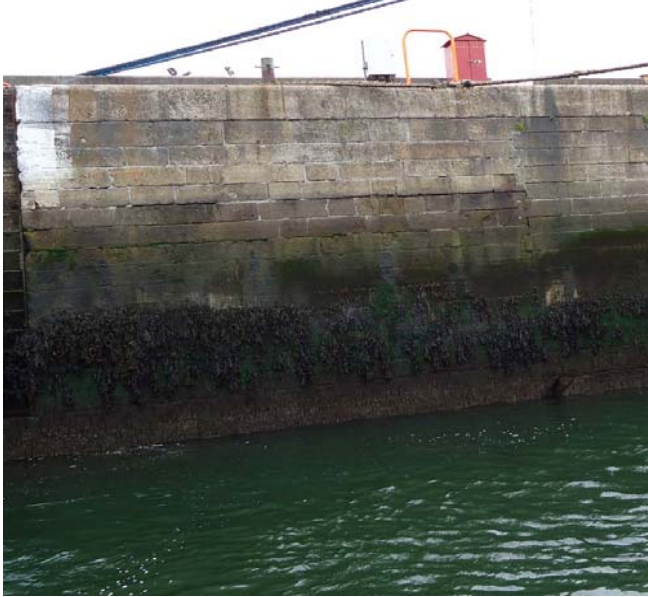
A photograph of a stone wall with a visible construction line. A red rail is visible on top of the wall. The water in the foreground is a murky green color.
View of steps below East Link Bridge	View of stonework and access ladder	View showing construction line in stonework (a staggered line below the red rail. This represents a break in Stoney's work and would date to the early 1870s.

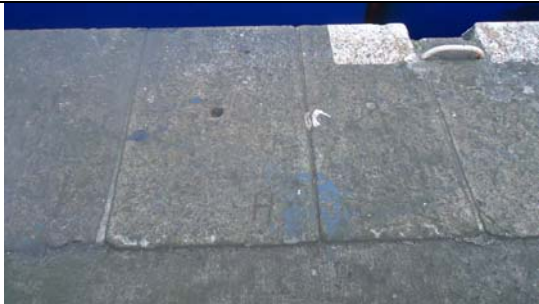
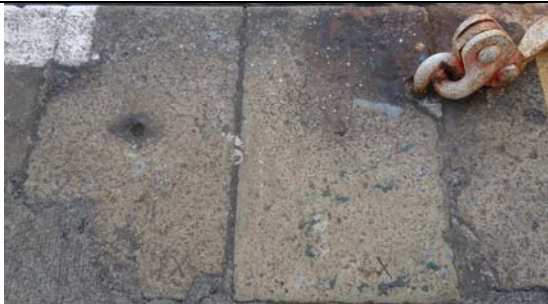
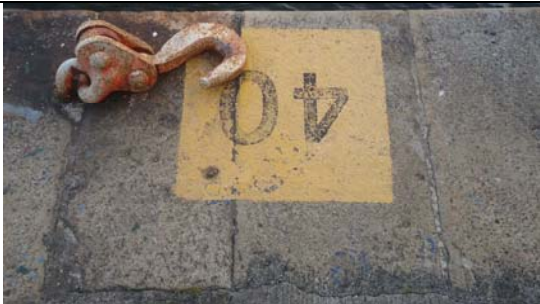
<p>Individual coping stone 92cm wide with mason's mark, 'H', Channel side, 718685E 734302N. The coordinates, suggests that this location is more or less coequal with the location of the North Wall lighthouse before it was moved to its current position in 1937</p>	<p>Sequence of three coping stones measuring 90cm, 90cm and 70cm wide x up to 1450cm long with mason's marks 'IX', 'X', 'XI' respectively, Channel side and part of Mallagh's extension, 92cm wide with mason's mark, 'H', Channel side, 718787E 734303N</p>

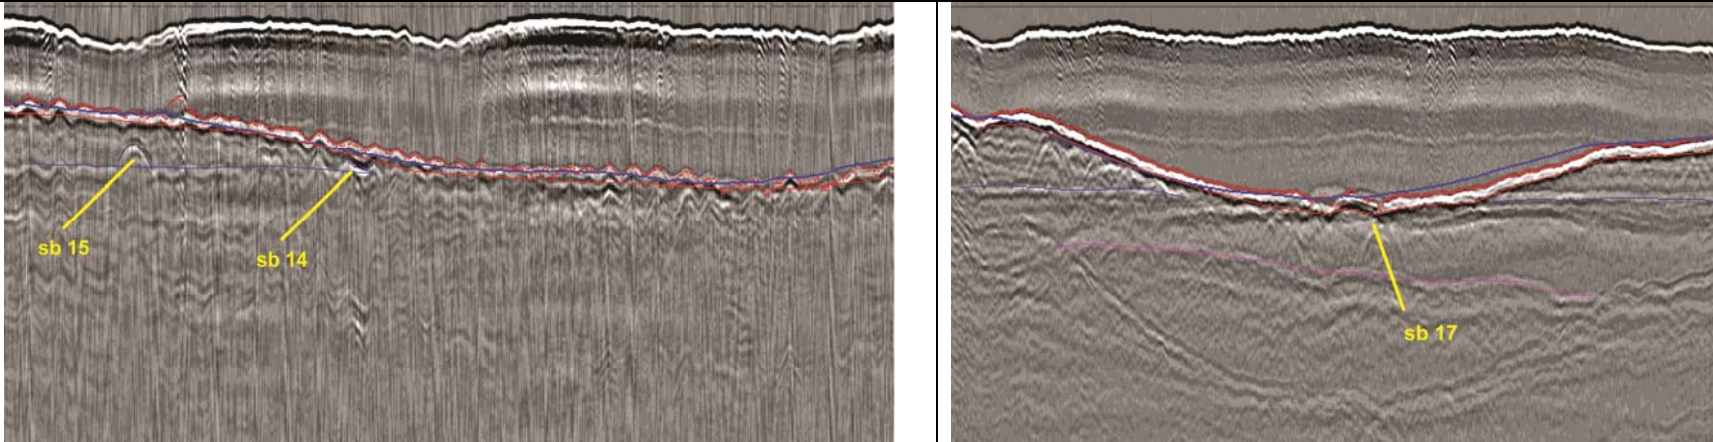
sb16	02/07/2013	144940	Reflector just below bed level. This target is located close to sb14 and sb15 and is also outside the impact area. Its presence in this undredged area suggests a possible archaeological feature. Figure 12.31	691154e 5914399n	724622.49	734290.3	<ul style="list-style-type: none"> <li>None, outside dredge area</li> </ul>
sb17	03/07/2013	55114	Reflector. Located in the central channel, c. 130m E of the harbour entrance, the target is 100m from the nearest other anomaly. Figure 12.30	689769e 5914302n	723236.32	734212.74	<ul style="list-style-type: none"> <li>Archaeological monitoring of dredging</li> </ul>
sb18	03/07/2013	63749	Reflector on side of channel. Target is c. 100m from any other anomaly but its location suggests the potential for	689979e 5914116n	723443.68	734023.82	<ul style="list-style-type: none"> <li>Pre-dredge dive</li> <li>Archaeological monitoring of dredging</li> </ul>

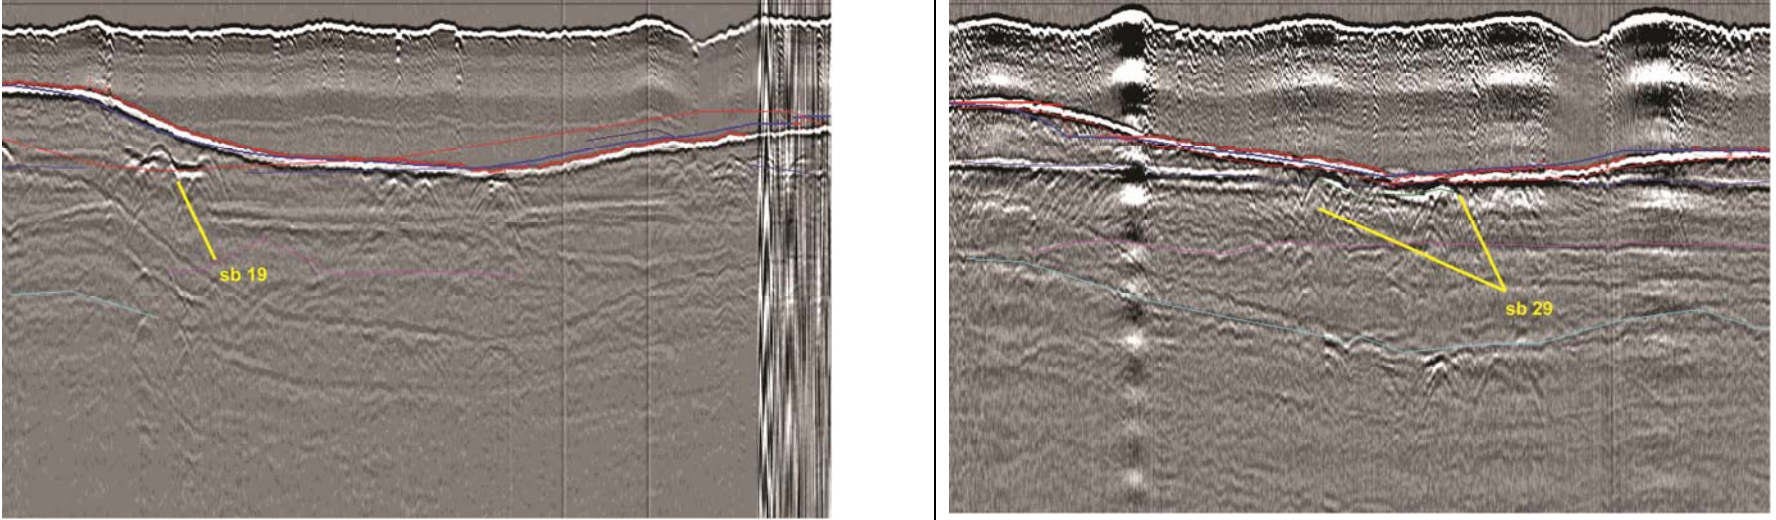
sb19	03/07/2013	64651	Multiple reflectors. These features may indicate old channel lines. Figure 12.30	690098e 5914141n	723563.02	734047.15	<ul style="list-style-type: none"> <li>• Pre-dredge dive</li> <li>• Archaeological monitoring of dredging</li> </ul>
sb20	03/07/2013	105333	Point object. Located in isolation from other targets. Figure 12.31	691300e 5914018n	724763.13	733907.33	<ul style="list-style-type: none"> <li>• Archaeological monitoring of dredging</li> </ul>
sb21	03/07/2013	121942	Reflector observed. Outside channel. Figure 12.31	691668e 5914361n	725135.89	734245.13	<ul style="list-style-type: none"> <li>• None, outside dredge area</li> </ul>
sb22	03/07/2013	65807	Repeat of reflectors seen on line 64951, but observed in the central channel area, indicative of palaeo-channel.	690074e 5914356n	723542.03	734262.46	<ul style="list-style-type: none"> <li>• Archaeological monitoring of dredging</li> </ul>

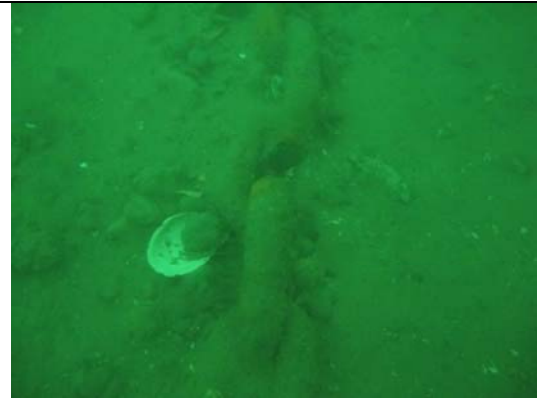
Dive Number	Date	Target Number	Diver	Dive Times	Depth	Description	U/W Photograph
				AS: 13:14		diameter with a slope of 45°.	
10	26.11.13	100_2	R.B.	LS: 13:47 AS: 13:55	10m	No object encountered at target location. Seabed composed of silty-sand, gently undulating, with occasional pockets of cobbles and rocks (sub-rounded).	No image
11	26.11.13	100_5	R.B.	LS: 14:39 AS: 14:45	9m	Two circular shaped pieces of iron (prob. part of old navigation marker), 1m+ diameter, upstanding 1.8m from the seabed. These objects lie directly north-south of each other, at a distance of 5m. The SMB weight was dropped directly between the two targets. A length of link chain (7m+ length) runs alongside the two objects and a separate pile of similar chain is located to the east of the southern object.

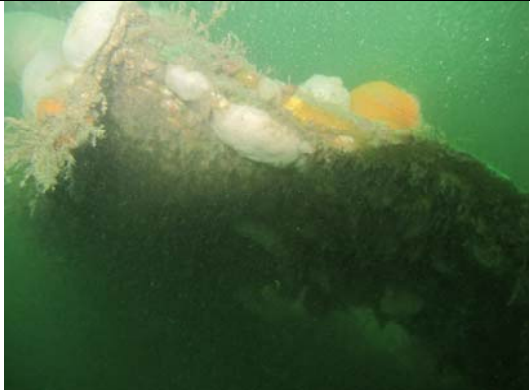
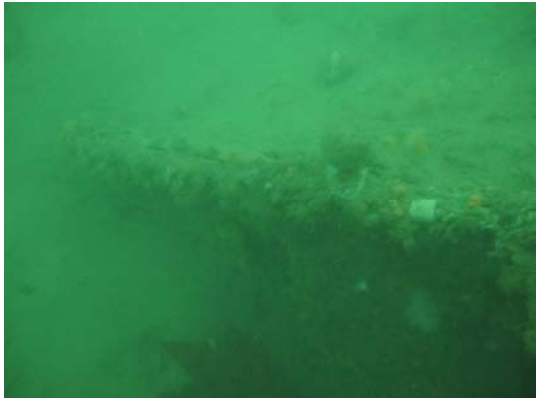
Dive Number	Date	Target Number	Diver	Dive Times	Depth	Description	U/W Photograph
12	26.11.13	26_3	R.B.	LS: 15:01 AS: 15:12	7m	Top of old Navigation marker, located on side of navigation channel. The object was located 2m from the SMB weight. The marker comprises of a square profile, box-section, and centre-piece measuring 40 cm x 40 cm x approx. 1.5m in length. Each corner has triangular-shaped wings that extend 30cm from the base of the object. The structure is 1.3m upstanding from the seabed and is surrounded by a large scour hole. Seabed composed of silty-sand with 5cm penetration.

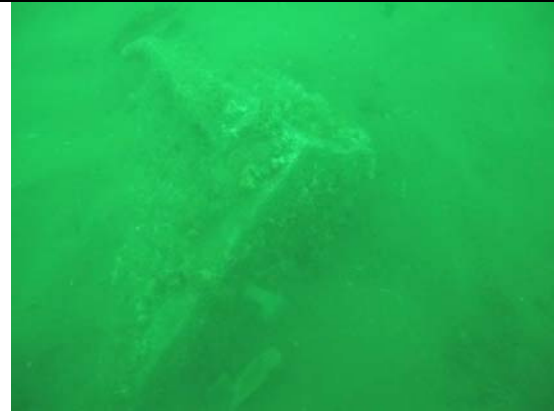
Dive Number	Date	Target Number	Diver	Dive Times	Depth	Description	U/W Photograph
15	27.11.13, 18.12.13	158_2	N.B.,  R.B	LS: 09:46  AS: 10:05	9m	<p>A car tyre (80cm diameter) was encountered 20cm from the SMB weight. In addition, a metal pipe was located 2m SE from the SMB mark. The pipe is octagonal in section and measures 1m in diameter, and protrudes from side of navigation channel; 3m from top of slope. A 2m wide flange extends from the pipe terminus. Seabed composed of silty-sand.</p> <p>A second inspection on 18.12 confirmed that the metal pipe protrudes from the side slope of the navigation channel, and determined that pipe has been damaged, having been grabbed previously and buckled. It remains possible that further remains are buried in the sands behind the side slope.</p>

Ref.	Latitude	Longitude	ITMe	ITMn	Description	Fig.	To Dive Y/N/ Dived	Arch. Potential	Further Interpretation/ Diver-truthing	Image
158_2	53°20.6792N	6°10.7446W	721248.32	734259.83	Central anomaly within circular shape.	12.17	Dive 15	L	Car tyre, Steel pipe observed close by. The pipe is sticking out of dredge slope at depth of 3m from top of slope. Appears to be previously grabbed and buckled.

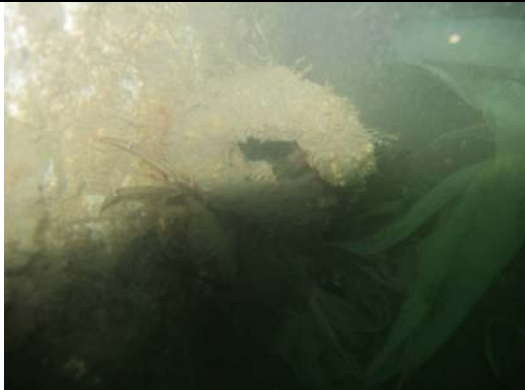
Dive Number	Date	Target Number	Diver	Dive Times	Depth	Description	U/W Photograph
17	27.11.13	161_1	N.B.	LS: 12:05 AS: 12:24	9m	One mooring block, measuring 1m x 1m x 1m, on seabed. Recessed metal eyes, no chain attached. Scouring evident around base of block and a length of timber is exposed within the scour. Timber measures 1.5m in visible length and is heavily encrusted with marine growth. Timber measure 3cm in thickness. Timber appears to be isolated object.

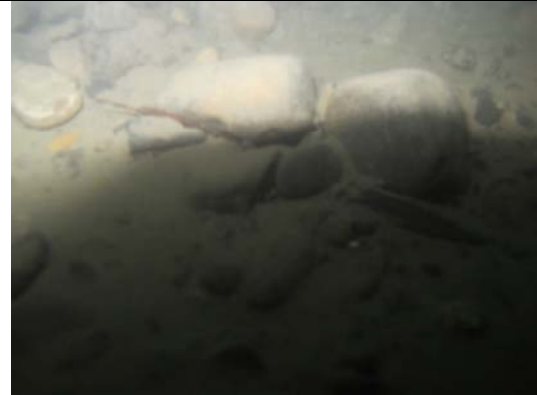
Dive Number	Date	Target Number	Diver	Dive Times	Depth	Description	U/W Photograph
21	27.11.13	01_3	R.B.	LS: 14:44 AS: 14:56	10m	Flat Featureless seabed composed of compact clay with deposit of overlying silt. A natural feature comprising a ridge of small sub-rounded stones, >5cm x 8cm in size, located within 1m of SMB weight [probable cause of side-scan shadow].

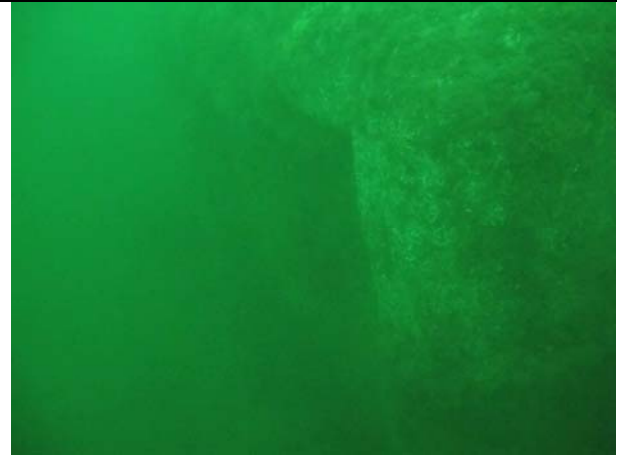
Dive Number	Date	Target Number	Diver	Dive Times	Depth	Description	U/W Photograph
23	28.11.13	102_3, 103_3, 111_2	R.B.	LS: 09:40  AS: 09:53	11m	Mooring block located 0.40cm from SMB weight. Chain wrapped around mooring block, lying on its side. Recessed metal eye located on top side and metal bolt protrudes from exposed base of block. 40cm deep scour hole located extends around the object. Seabed is composed of a compact silty-sand.

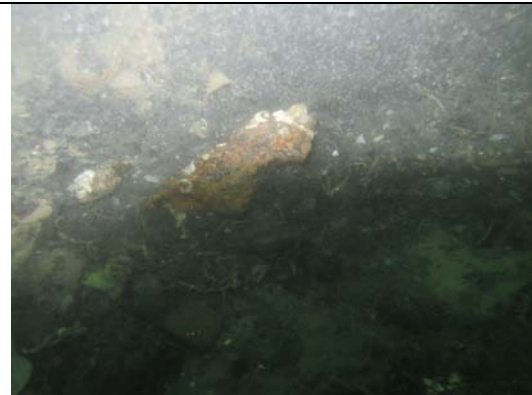
Dive Number	Date	Target Number	Diver	Dive Times	Depth	Description	U/W Photograph
				AS: 10:53		situ bedrock located close by. Seabed composed of compact flat/featureless, silty-sand.	
26	28.11.13	4_1	R.B.	LS: 11:13 AS: 11:33	11m	North-south depression in seabed that extends c.5m. This feature has almost vertical walls, 25cm deep, and measures 40cm in width. Small stones and clumps of slag like material present within this trench-like feature. Seabed at this location is composed of compact clay with frequent scarp marks visible.

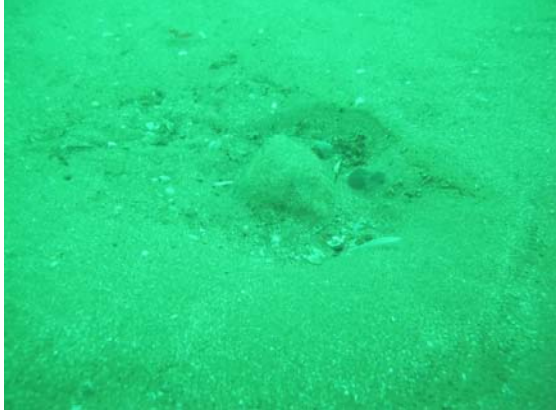
Dive Number	Date	Target Number	Diver	Dive Times	Depth	Description	U/W Photograph
28	28.11.13	39_1	R.B.	LS: 14:05 AS: 14:12	11m	Large boulder , measuring 45cm length x 20cm width and upstanding 30cm from seabed. The boulder is surrounded by a scour hole measuring 15-20cm in depth.

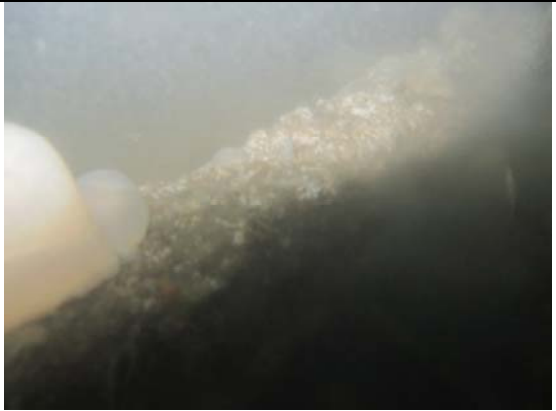
29	28.11.13	46_4, 36_2	R.B.	LS: 14:59 AS: 15:16	11m	Series of exposed sections of iron from a possible structure buried with the seabed at this location. Largest section measures 1.4m in length, 5cm width, and 8cm in thickness. The iron is covered in marine growth, however, the metal appear to be of modern origin. Surrounding seabed composed of compact clay.

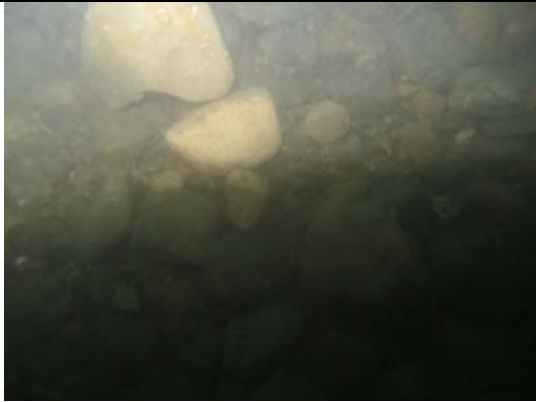
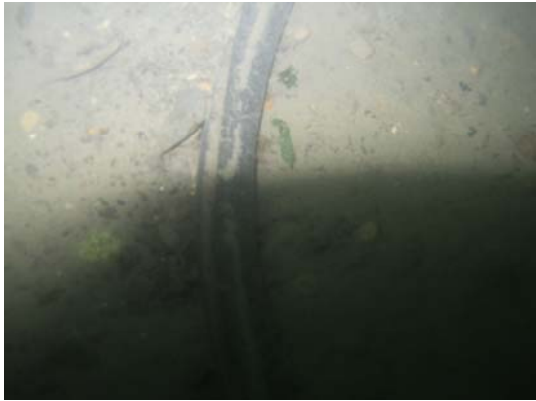
Dive Number	Date	Target Number	Diver	Dive Times	Depth	Description	U/W Photograph
33	29.11.13	1_4	R.B.	LS: 11:29 AS: 11:42	11m	Ridge of water-sorted cobbles and gravel running east-west and sloping to the north; located 3m from the SMB weight. Cobbles similar to river cobbles and measure up to 15cm x 8cm in size. Surrounding seabed composed of silty-clay with a hand-penetration of 20cm. Some modern debris noted in this area, including miscellaneous iron objects and a length of 3inch pipe.

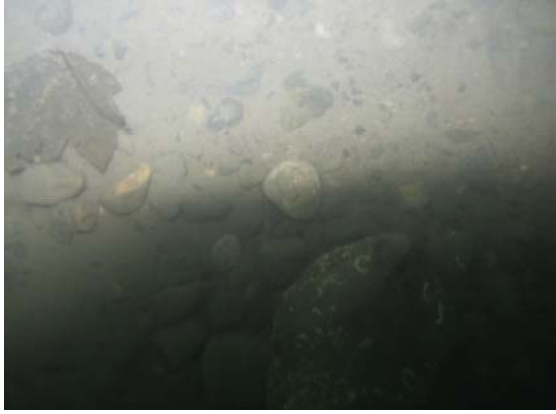
Dive Number	Date	Target Number	Diver	Dive Times	Depth	Description	U/W Photograph
34	29.11.13	15_3	R.B.	LS: 11:55 AS: 12:10	12.5m	Area of water-sorted cobbles and gravel located within a depression in the seabed, approx. 30cm depth of scour. Compact clay located north of the cobble deposit.
